## Case Study: Meat Processing Plant

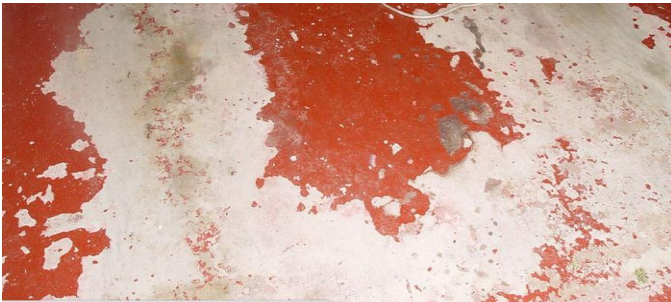
A meat processing plant in the old “stockyards” district of Chicago had an inspection coming up. The owner knew he needed to repair the flooring - or be fined. The concrete floor slabs in the more than 100 year old building were degraded and had the patchy remains of various types of coatings, unsuccessfully applied over the years. Much of the concrete was now bare and well-saturated with animal grease, soil and other contaminants. Plus, the slick surface was a serious threat to worker safety.

*Unsanitary floors with remains of failed concrete coatings.*

The highly experienced, Approved Florock Installer was able to degrease and mechanically prepare the floor overnight, then install FloroCrete HT/PT, RT and SLX in different rooms, based on the substrate condition, typical floor traffic and activity in the room. The floor-to-wall canted cove base was skillfully built with FloroCrete HT/PT and topcoated with SLX. Skid-resistance was customized in accordance with the building owner’s request. By adding a touch of catalyst to the blended liquids prior to application, the FloroCrete floors, despite cool curing temperatures, were ready for employees on Monday morning.

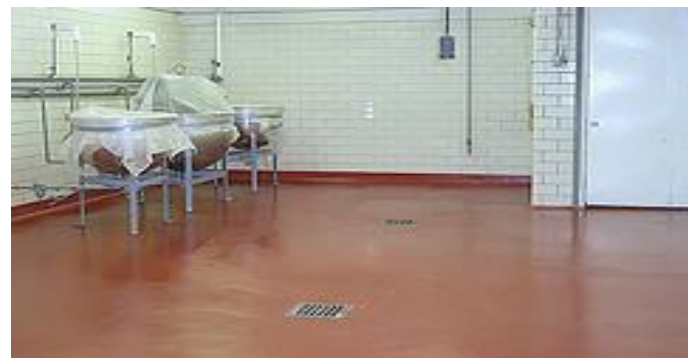
*Hygienic, seamless FloroCrete Flooring w/ integral cove base.*

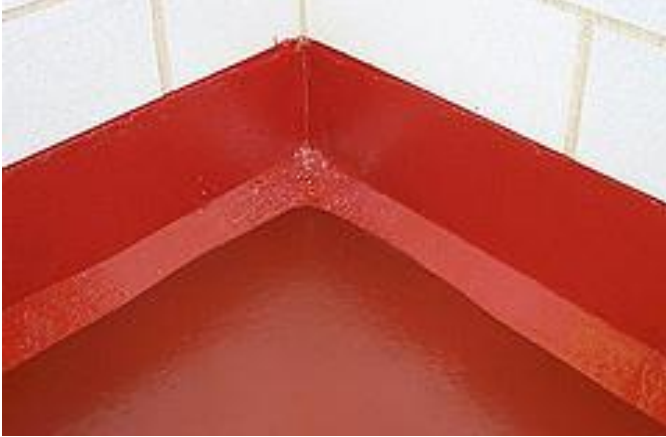
*Canted cove-to-wall base, skillfully installed using FloroCrete.*
